# Colonnade North Tower, South Tower & Parking Garage

Worthouse DURA Mediterranean Steel Tile  
+ 100% Silicone Flat-Roof Coating

800 Douglas Road  
Miami / Coral Gables, FL 33134

September 23, 2026 · Ref: COL-NST-PG-2026-PRO

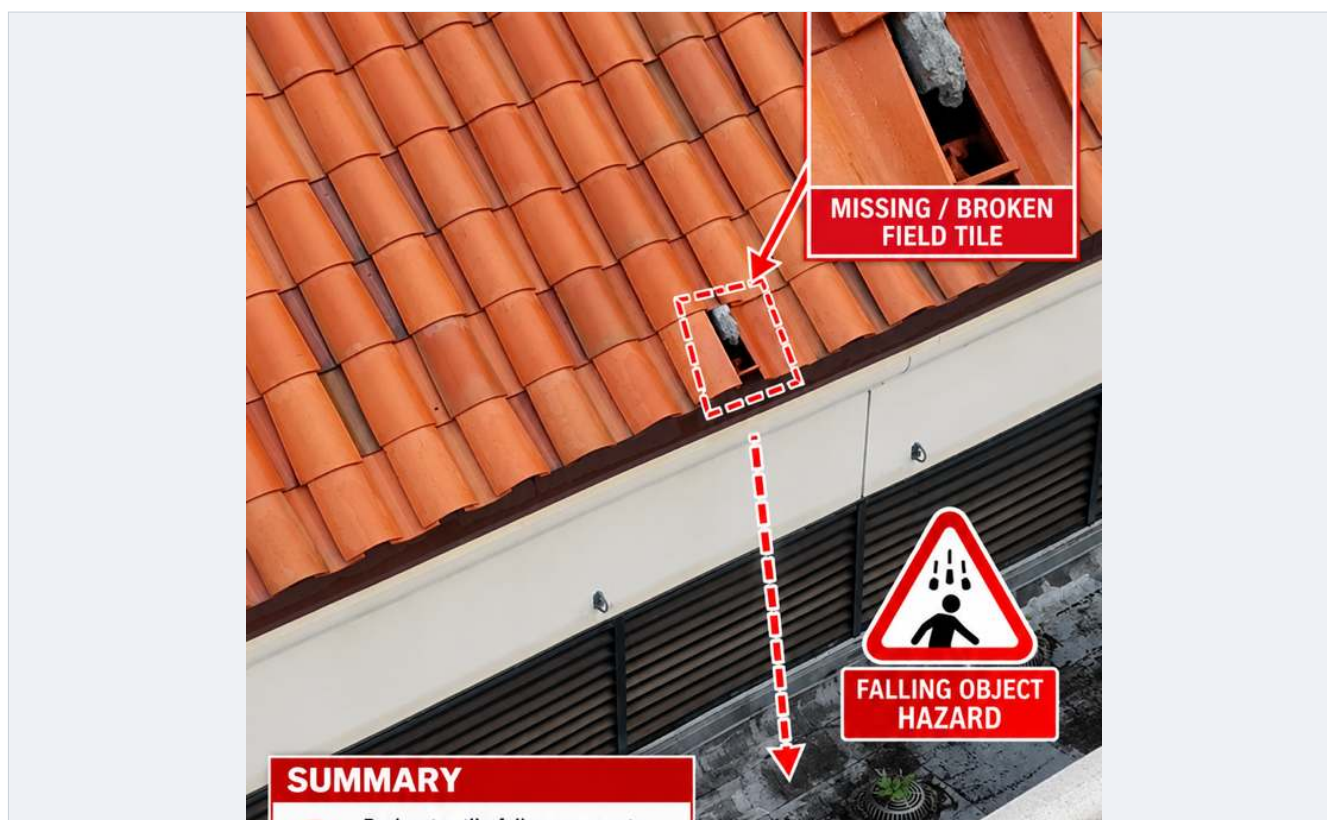
**At elevation, wind is stronger and behaves differently.** Higher wind pressures at tower height explain the many broken and displaced tiles even though there has not been a recent hurricane. Clay that performs acceptably on low-rise buildings presents a different maintenance profile on these approximately 10:12 high-rise roofs. Every future service call reintroduces crane or swing-stage cost, exclusion zones, and disruption for localized breakage or ridge repair.

North Tower — broken and displaced clay tiles at elevation

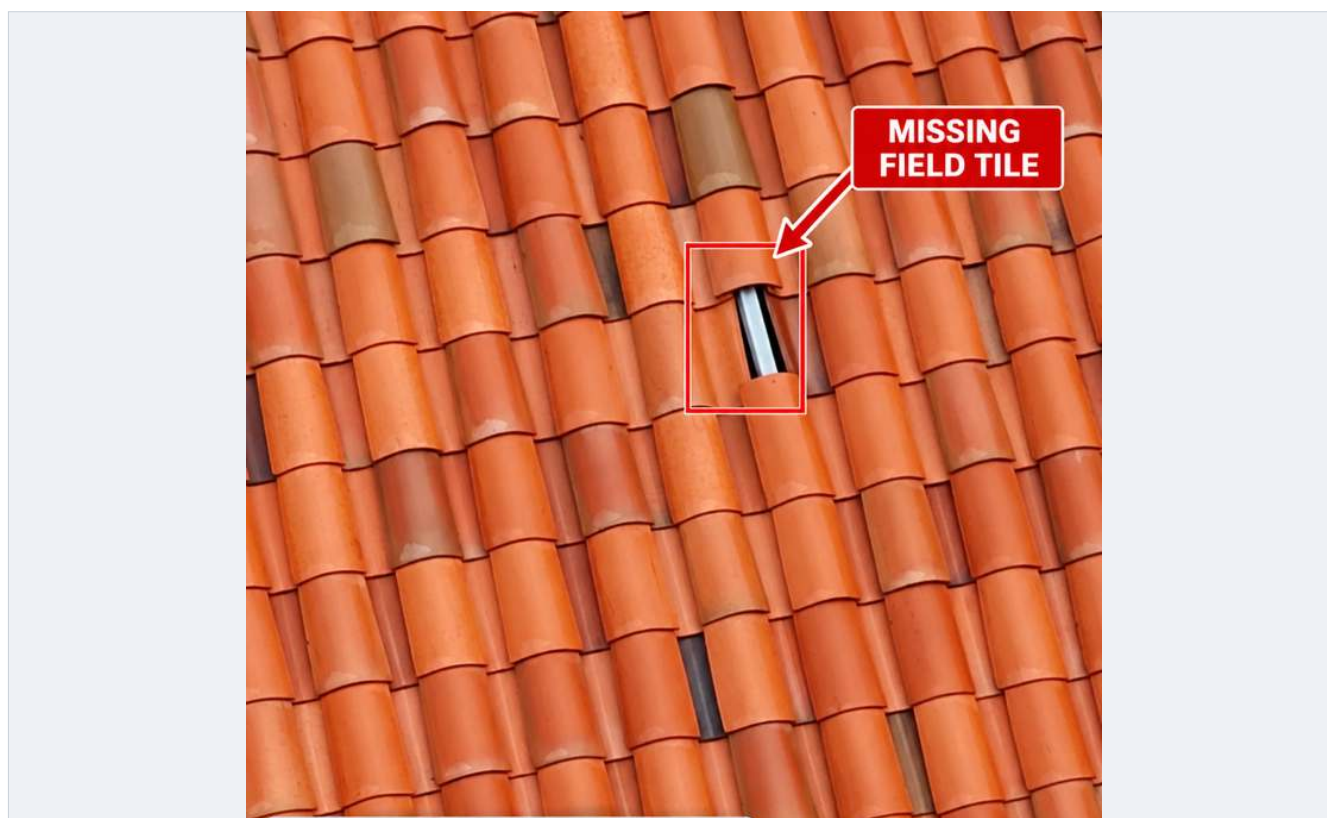
North Tower — missing field tiles; wind exposure at height

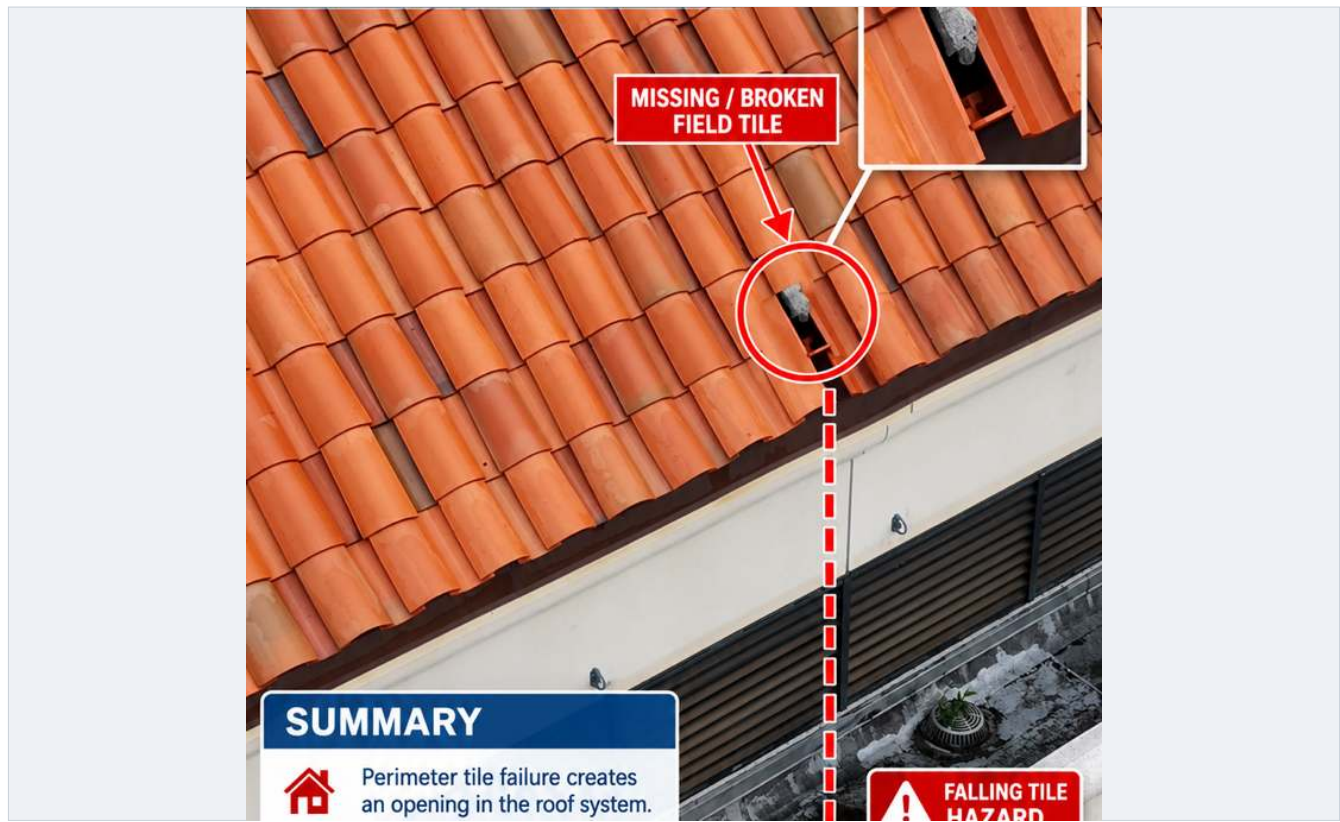
North Tower — broken clay; elevated wind-pressure damage

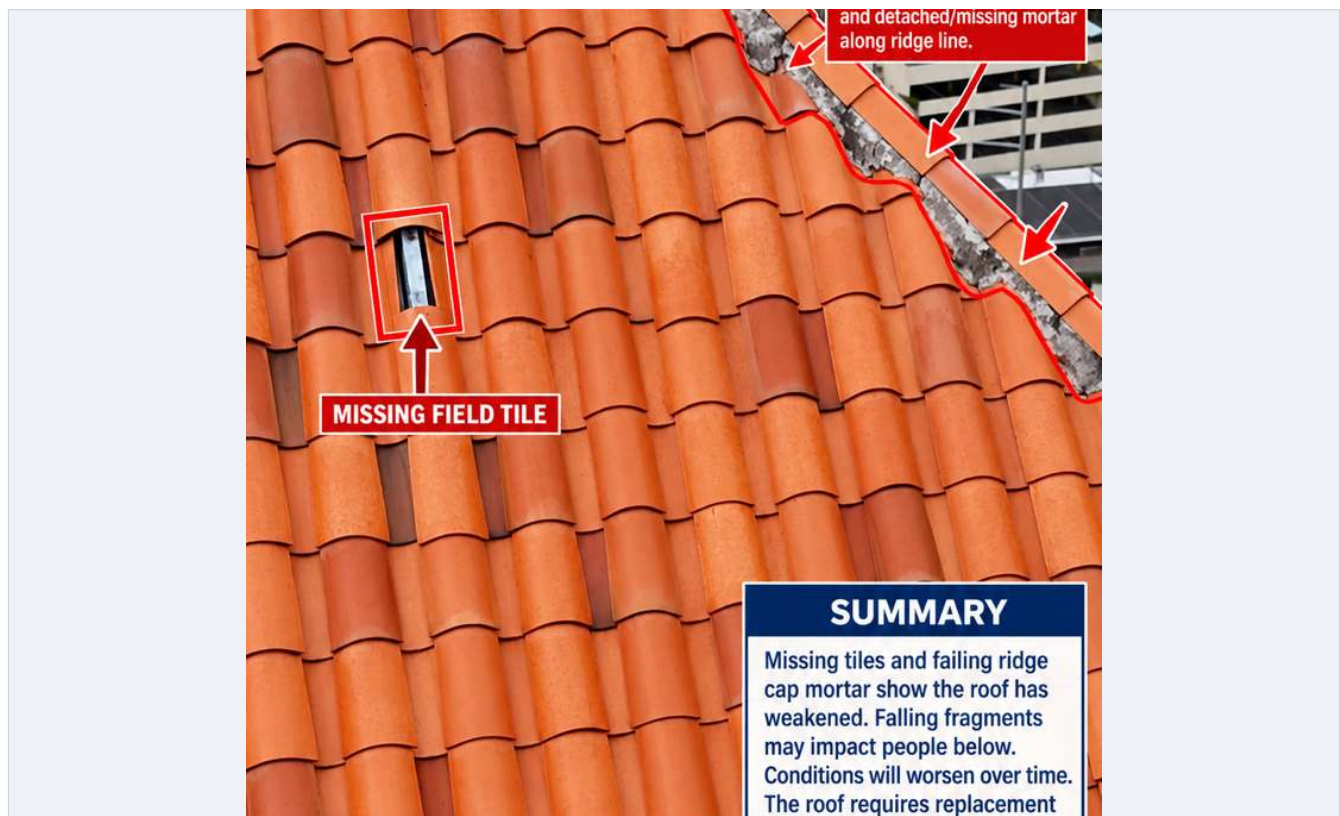
**Cement and mortar are deteriorating quickly.** Ridge beds, caps, and field bedding that rely on cementitious materials crack, loosen, and shed. On high-rise Mediterranean clay in South Florida, ridge cement typically requires monitoring and re-bedding on a roughly 3–7 year cycle (average ~5 years) simply to keep components secure. Left unaddressed, this is a near-term capital and maintenance issue — not a distant cosmetic item.

North Tower — ridge mortar brittle and deteriorating

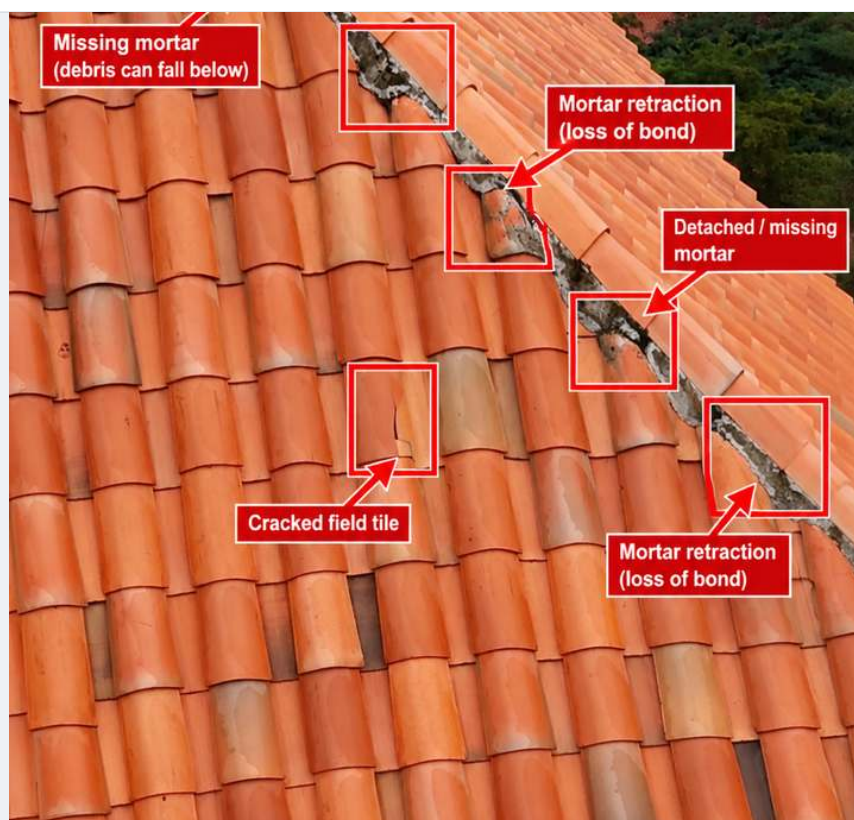
North Tower — cement/mortar cracking along bedding

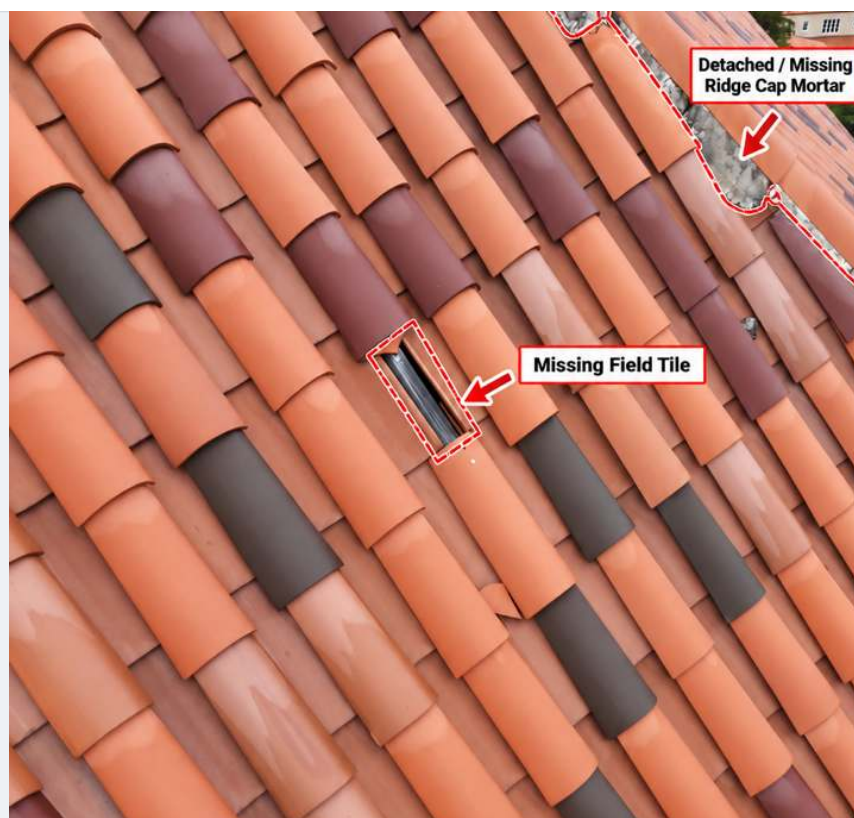
South Tower — missing mortar and ridge distress at height
